ADOPT-A-BEACH PROGRAM

Long-Term Monitoring of Camping Beaches in Grand Canyon

Summary of Monitoring Observations for Year 2015

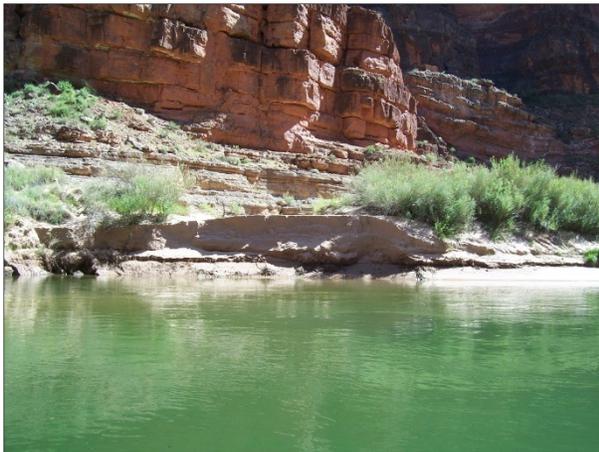
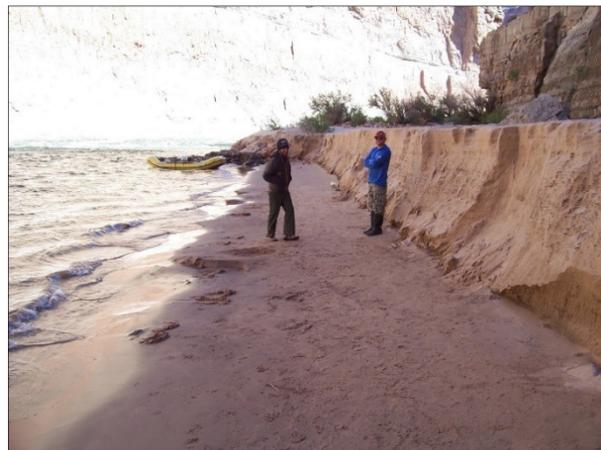
*Examples of beaches with fluctuating flow cutbanks after HFE deposition.
Tatahatso Camp, RM 37.9 L (left) and Shinumo Wash Camp, RM 29.4 L (right).
Both photos taken 4/3/2015.*
